# SITE INSPECTION of the DRUMCO SITE (MD-408)

**Revision II**

March 26, 2012

Prepared by: Maryland Department of the Environment

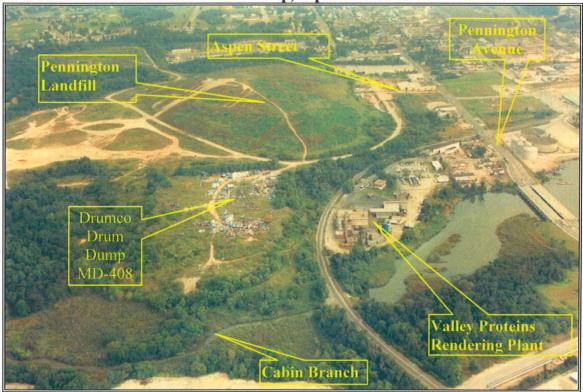
The former Drumco Drum Dump Site consists of a mounded grassy plateau surrounded by trees growing along the slopes of the plateau (Figure 2). The southern portion of the Site is situated on illegally backfilled wetlands. The Valley Proteins rendering plant is located to the east of the Site beyond the railroad tracks. The Baltimore Pennington Landfill (now closed) is located to the north of the Site. The southern portion of the Site lies adjacent to wetlands and the tidally influenced portion of Cabin Branch. A Hess Petroleum Terminal is located south of Cabin Branch and the Drumco Drum Site. Cabin Branch flows into Curtis Bay, which is contiguous with Baltimore Harbor and the Chesapeake Bay. An intermittent stream valley lies directly to the west of the Site.

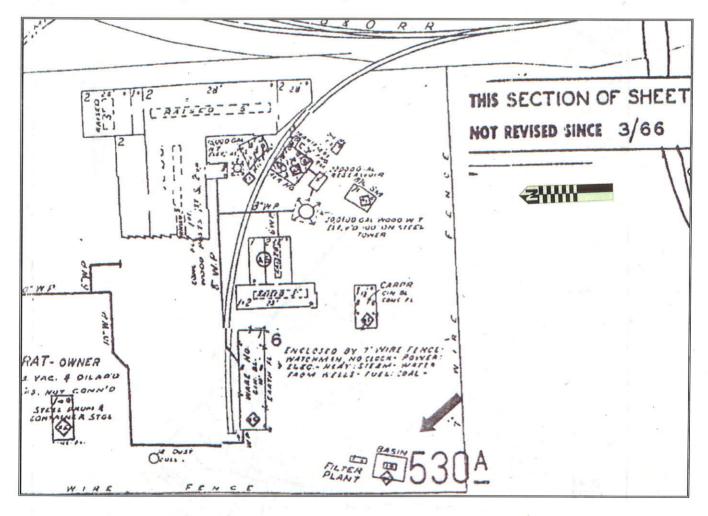
Figure 7: Sanborn Map of the Former Tannery

destroyed by fire. This portion of the building is also missing from the 1966 Sanborn Map (Figure 7). Piles of drums, possible solid waste, and debris are still present in the northern portion of the Site.

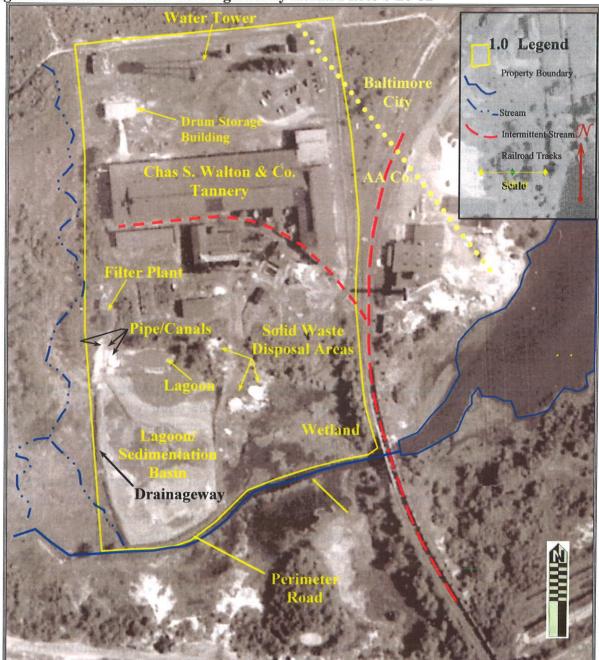
In the June 20, 1952 aerial photograph (Figure 8), the Chas S. Walton & Company, Inc. tannery appears to be in its prime period of production. The tannery was located near the Baltimore and Ohio Railroad and operated a side rail spur for receipt and delivery of materials. In the northwest portion of the property a lighter toned building identified on the Sanborn Map (Figure 7) as containing steel drums is visible. A probable liquid waste treatment area consisting of two lagoons appears to have been created in a natural wetland area adjacent to Cabin Branch Creek and a drainage way, which flows directly into the creek, is located to the west side of the probable treatment area (EPA, 2008). Probable canals or piping systems sustaining the two lagoons and drainage way are visible emanating from the filter building. Solid waste disposal areas are located east of the lagoons. It should be noted that in the tanning industry, waste pits were used for acid wastes from the grease-rendering fleshing process and for caustic wastes from the patent leather process. In addition, alkaline waste streams from the tanning processes were routinely transported to filter buildings for removal of solids and then to lagoons for long-term sedimentation. Wastewater potentially containing chromium also was typically discharged into rivers and creek systems. Overall, drainage in the general vicinity flows southward into the wetland area and Cabin Branch Creek, which flows easterly into Curtis Bay (EPA, 2008).

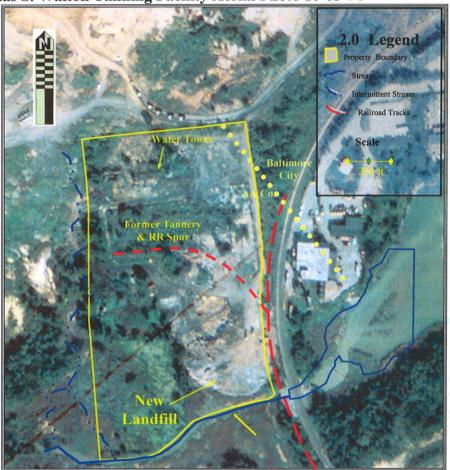
Figure 9: Chas S. Walton Tanning Facility Aerial Photo 10-05-74

By September 1970, the former tannery appears inactive as all of the primary buildings have been demolished/burned down and vegetation appears within the main tannery building. The former Drumco Site is overgrown in 1973 with no activity. In October 1974, most of the drums and debris are no longer visible. However as described by EPA, a new landfill area has been created in the southeast corner of the property and several trucks are visible on what appears to be a mound of solid waste. This material was deposited immediately adjacent to the mouth of Cabin Branch Creek (Figure 9).

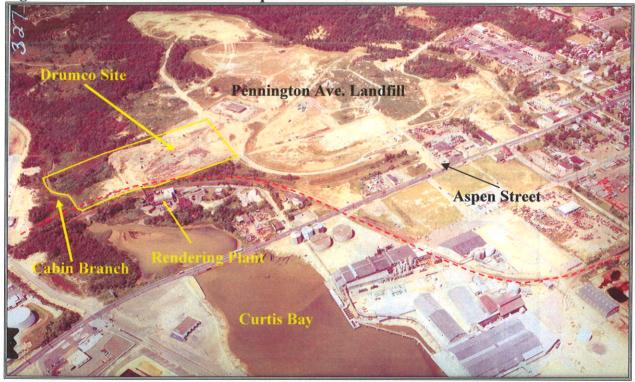
Figure 10: Former Drumco Site Oblique Aerial View 08-08-76

In 1976, significant grading and filling activity is present. It has been observed that the Former Drumco Site received rubble and construction debris fill from approximately 1975 until the early 1980s. It is estimated from the change in topography that approximately 30,000 to 40,000 cubic yards of fill were received (CES, 2004). However, CES reported that it was not known whether any of the materials brought onto the Site were hazardous.

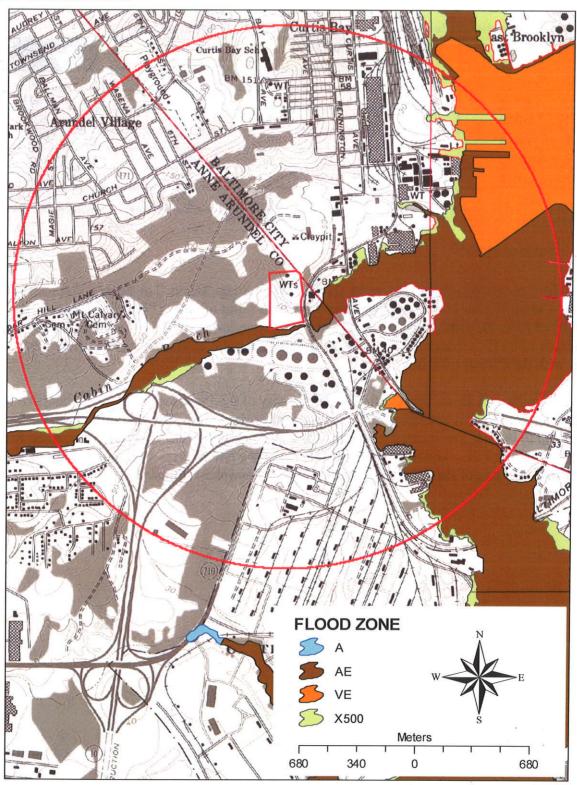
Figure 11: Flood Zones

Cabin Branch flows into Curtis Bay, an estuary of the Patapsco River. The Patapsco is a tidal estuary utilized by numerous fish populations for spawning. The tide influences Cabin Branch up to the fall line located just west of the Drumco property. There are no surface water intakes along the PPE. The Site is bounded by estuarine and riverine wetlands along much of its course and portions of the site lie within the 10-year floodplain (Figure 11).

A=100 year flood zone; AE=100 year flood zone w/BFE; VE=100 year flood zone w/velocity hazard; X500=500 year flood zone; X=outside 500 year flood zone; BFE=Base Flood Elevation

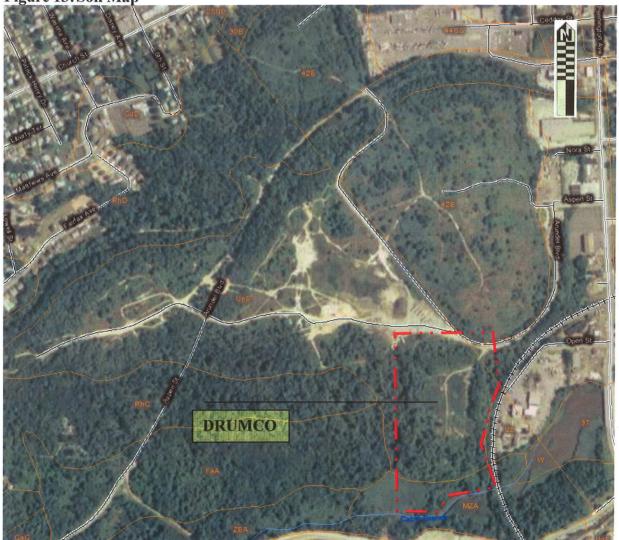
The soils occurring on and in the vicinity of the site belong to the Udorthents and Mispillion soil series. The majority of the soil found at the Drumco Site are in the Udorthent series (UpB in Anne Arundel County and 42E in Baltimore City). These soils are well drained with a slight to moderate slope (0 to 35%) with the water table found generally less than six feet below ground surface. The remaining soils on the property are classed as Mispillion and Transquaking soils with a slope of less than one percent. These soils are very poorly drained and are very frequently flooded (Figure 13).

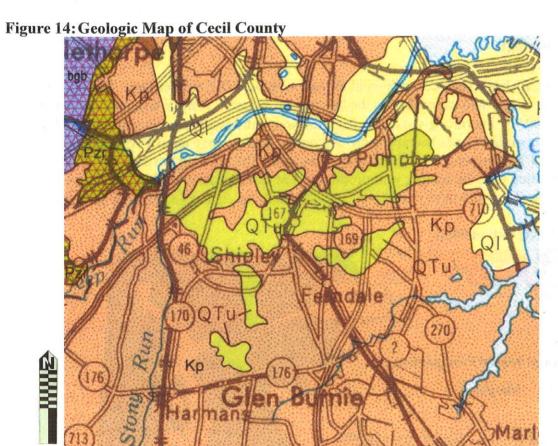
The site is situated on artificial fill consisting of heterogeneous materials such as rock and brick fragments, gravelly sand and unconsolidated sediment. The top geological strata in the area of the site are Quaternary Lowland Deposits consisting of medium to coarse grained and varicolored gravels, sands, silts and clays. Below the surficial sediments are the Cretaceous strata of the Potomac Group. The Patapsco Formation, which is made up of sand and interbedded with layers of silty clay predominantly made up of quartz, illite and kaolinite, is known to be approximately 60 feet thick. The next layer is the Arundel Formation, which is a clay layer known to be approximately 140 feet thick, interbedded with lenses of sandy silt containing traces of lignitic material. The clay minerals are predominantly kaolinite and illite. The subsequent underlying strata is the Patuxent Formation and is made up of sand and gravel with interbedded lenses of silty clay with quartz as the predominant mineral. The Patuxent Formation is underlain by bedrock consisting of a complex assemblage of schist, gneiss and gabbro (Figure 14).

Potomac Group - Interbedded quartzose gravels; protoquartzitic to orthoquartzitic argillaceous sands; and white, dark gray and multicolored silts and clays; thickness 0 to 800 feet.

Raritan and Patapsco Formations - Gray, brown, and red variegated silts and clays; lenticular, cross-bedded, argillaceous, subrounded sands; minor gravels; thickness 0 to 400 feet.
